Hamilton-Coleraine Rail Reserve

Environmental Audit & Revised Management Plan

2008

PR Bird & RE Raleigh
for the
Hamilton-Coleraine Rail Reserve Committee

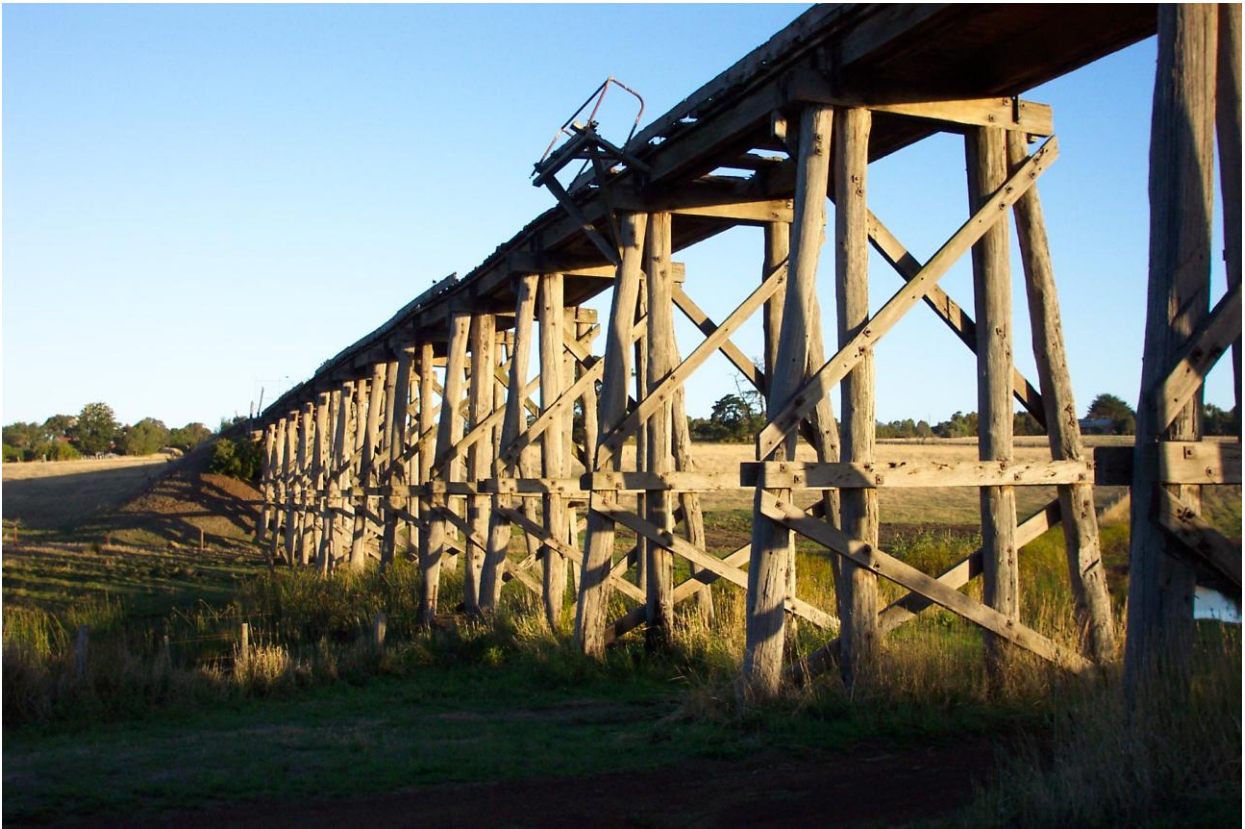
Historic Trestle Railway Bridge over the Grange Burn waterway, Young St-Elizah St, Hamilton
(Photo: B. Warton)

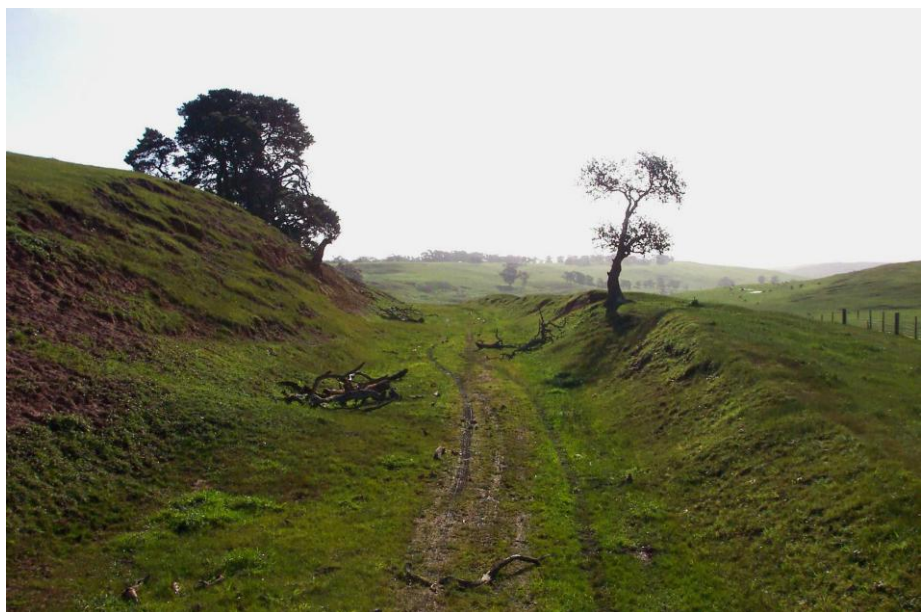
Loss of side-fences in Unit 10 (Koroite Decline) has led to the degradation of the public asset; a lone indigenous Silver Banksia clings to life against the odds.
(Photo: B. Warton).

- as an interim measure, the Committee will allow an adjacent landholder who has either removed the side fence or failed to maintain it, time to repair or replace it. The Committee will endeavour to assist the landholder to replace the fence, if funding opportunities arise, but it is the landholder's responsibility to maintain or replace the fence (*Fences Act 1968*) and to prevent livestock wandering outside the property;

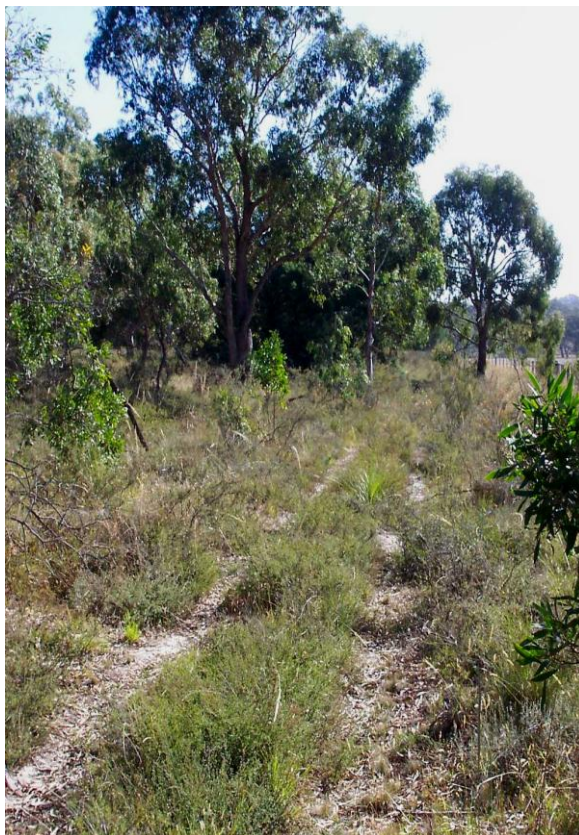
Class I vegetation. Excellent condition.
Native species are dominant.
(The degrading track will be shifted to centre of line).
Unit 5N - near Nigretta Road crossing.
(Photo: B. Warton)

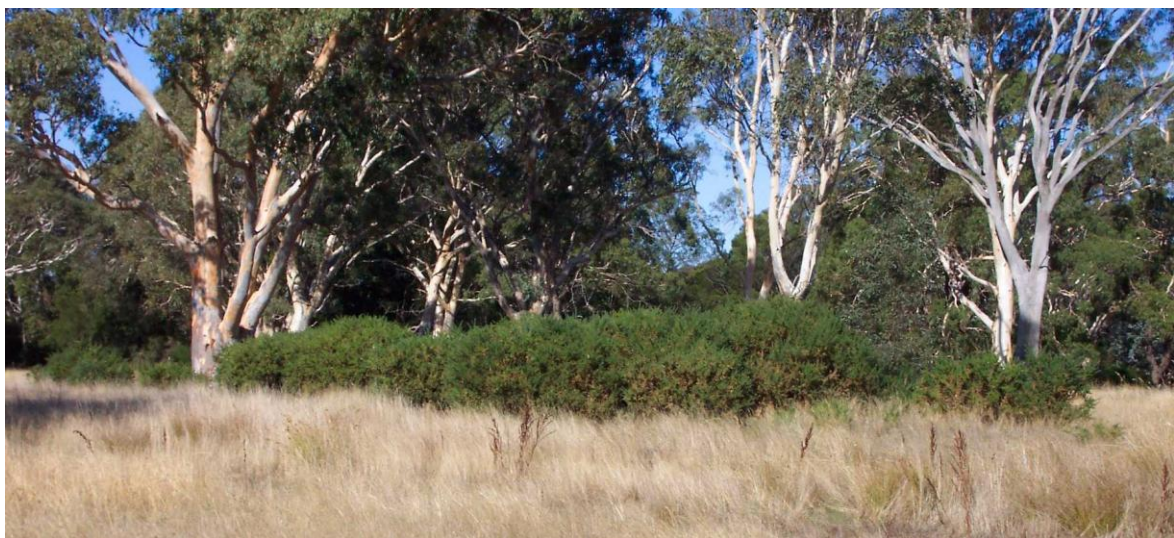
Ulex europaeus (Gorse) at Wannon Station Ground – control measures required.
(Photo: B. Warton)

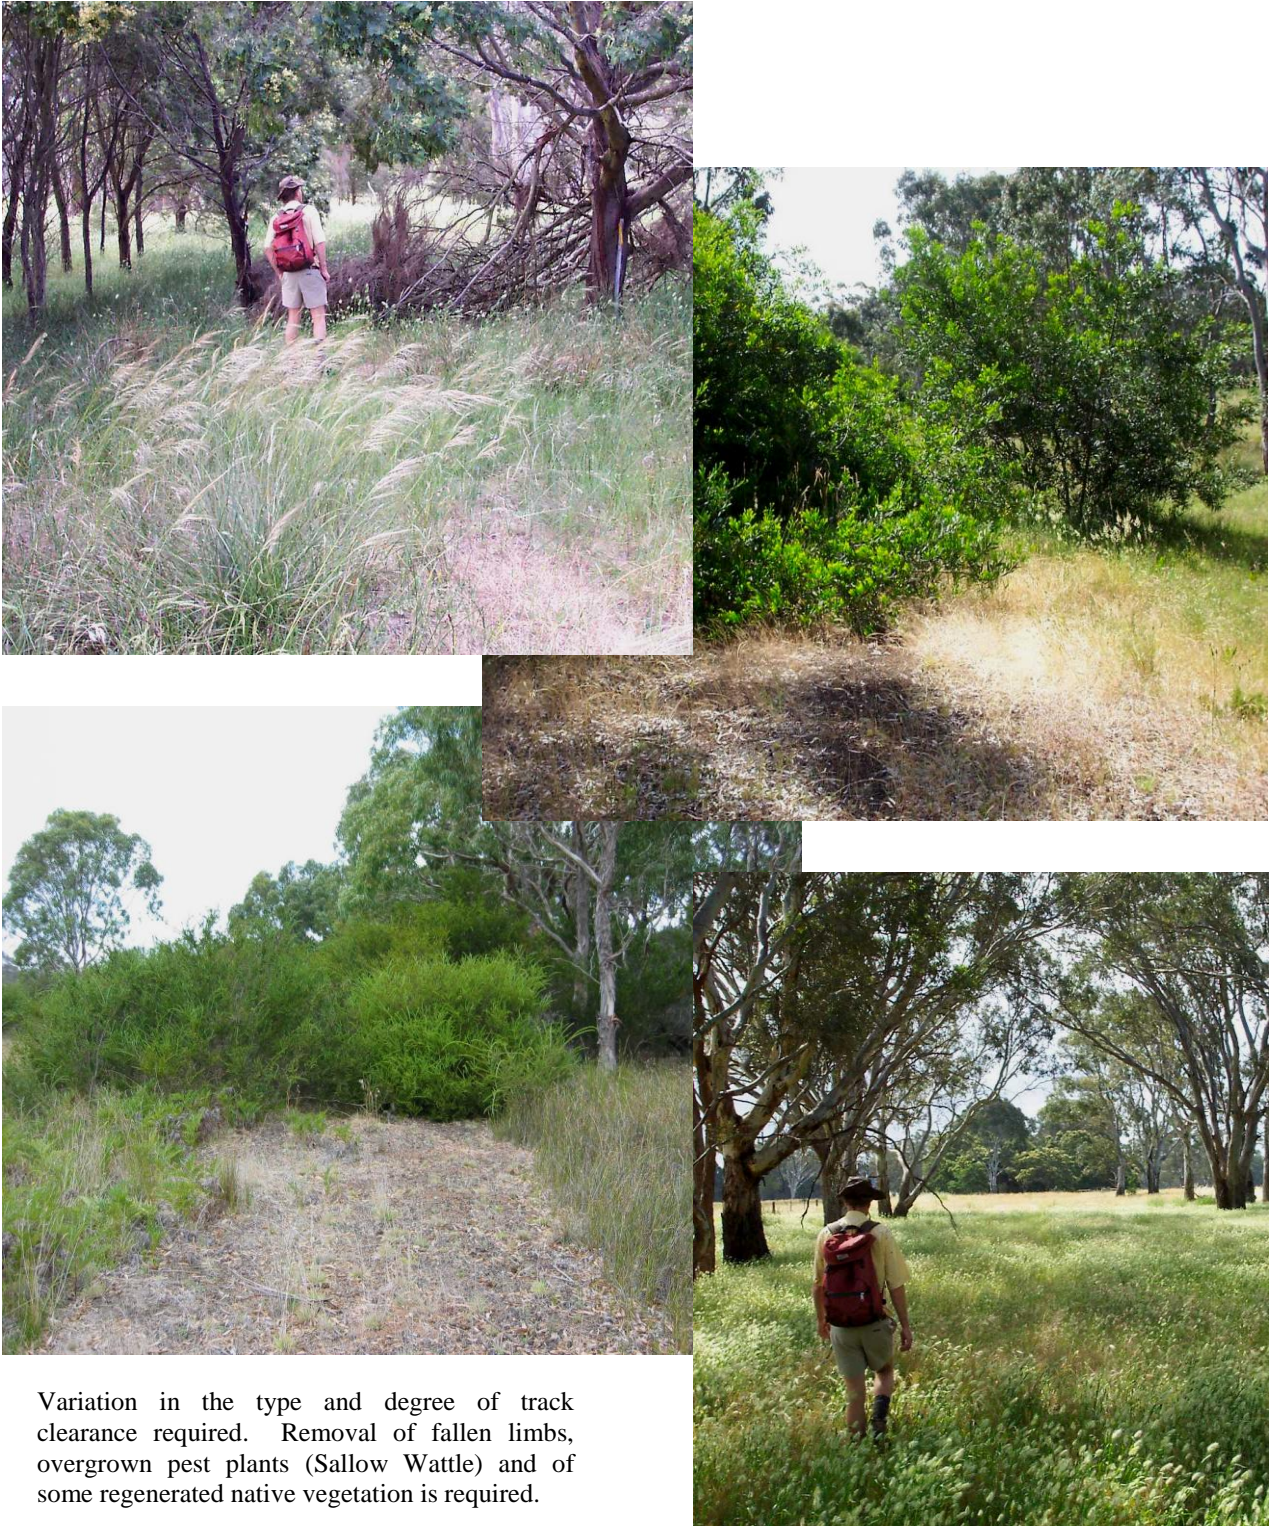
Variation in the type and degree of track clearance required. Removal of fallen limbs, overgrown pest plants (Sallow Wattle) and of some regenerated native vegetation is required.

A narrow (2-3 m), slashed track should be made on the centre of the former rail line. This generally provides the best all-weather access and is already serviceable in most parts without further work. This position generally offers the least disruption to native vegetation, which is usually best on the verges (there are exceptions). Annual slashing of the line will be required to keep the trail open. Considerable work in the form of clearing over-hanging branches needs to be done on the steep section just west of Wannon (Unit 8) in order to provide access. Without such access it will not be possible to control weeds or grazing animals, maintain a walking/cycling trail or provide easy access for fire protection or control.

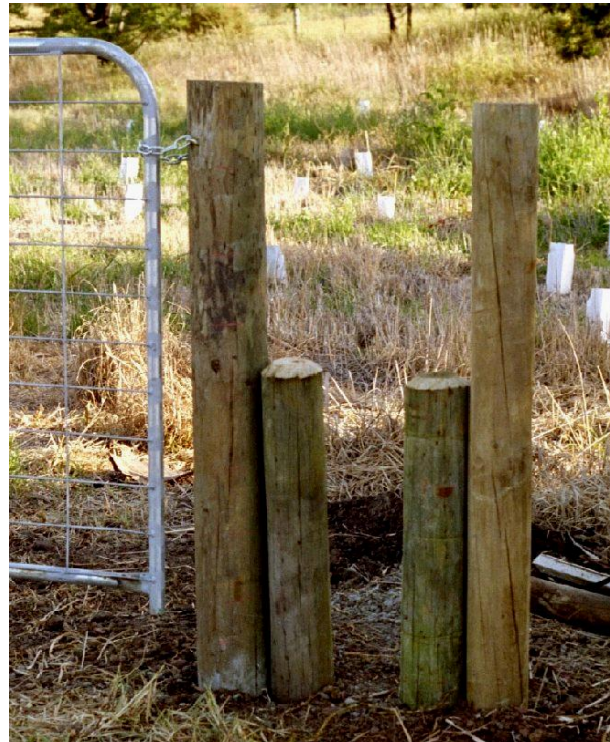
Photo (below) - a well-positioned gate on the rail bed in Unit 4K. This is also a grazed stock crossing point. “Tombstone” gates have subsequently been installed there.
(Photo: B. Warton)

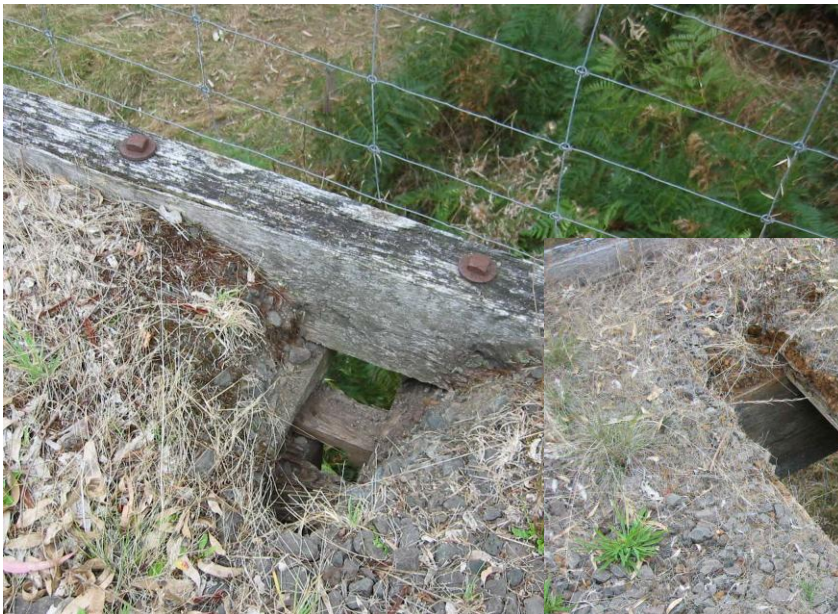
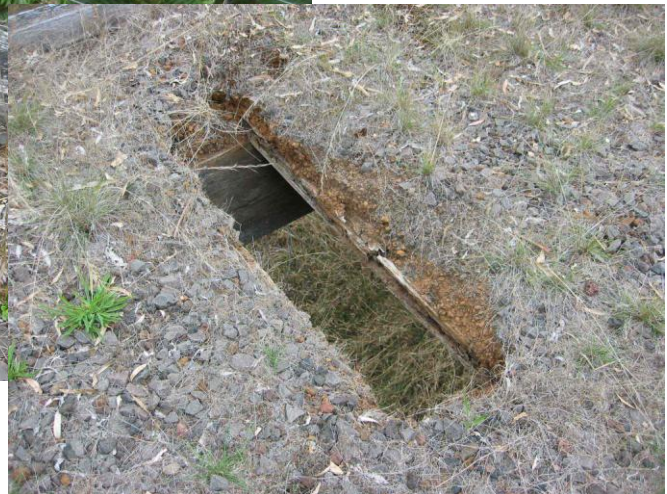
Replacement of rotted sleepers over bridges and culverts is necessary to make the track safe for pedestrians (and vehicles where alternative routes are not available).

There is a need for some rustic repairs to a few wooden culverts. Generally this entails the replacement of some sleepers in the wooden culverts (small bridges) to ensure safe passage of light vehicles, bicycles and walkers. It is not be feasible to attempt major works – such as a bridge over McKinnon Creek – and these difficulties must be overcome in other ways.

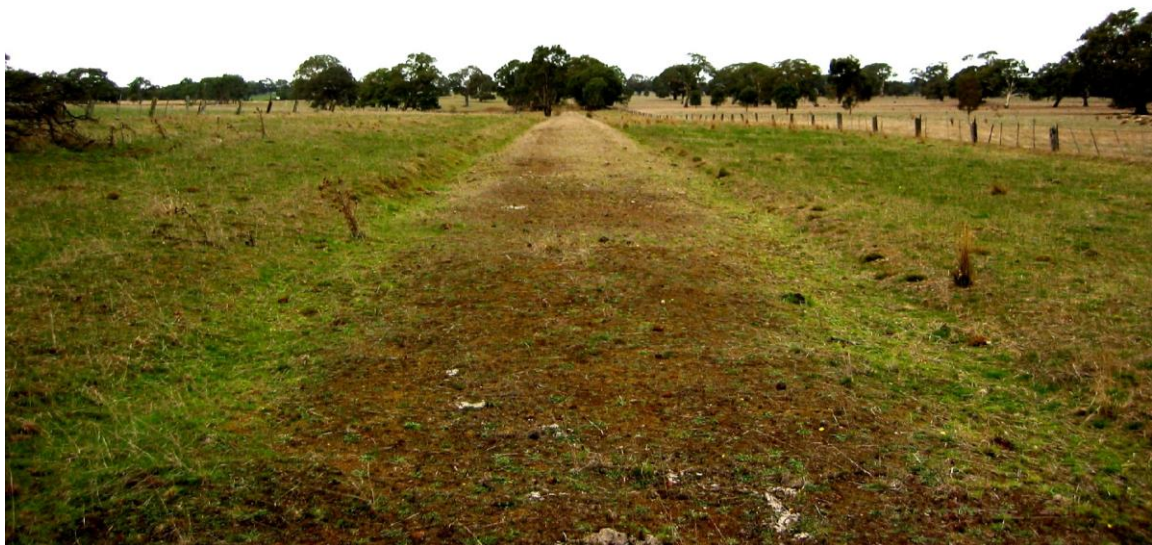
Unit 3F (Area F₄) – Looking east from Chadderton's Rd in spring 2004 – excellent native grassland degraded at this time by cattle. (Photo: B. Warton).

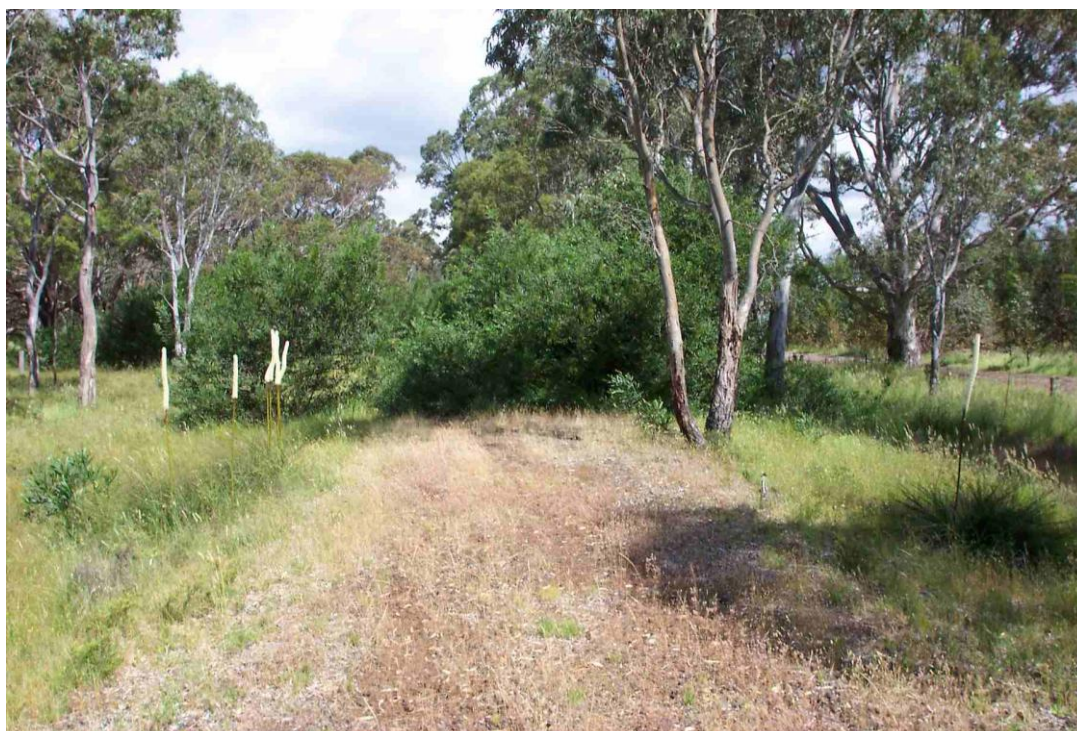
Good remnant vegetation including Grass-trees, but invasion by Sallow Wattle (*Acacia longiflora*) requires pest plant management [the *A. longifolia* has since been removed].

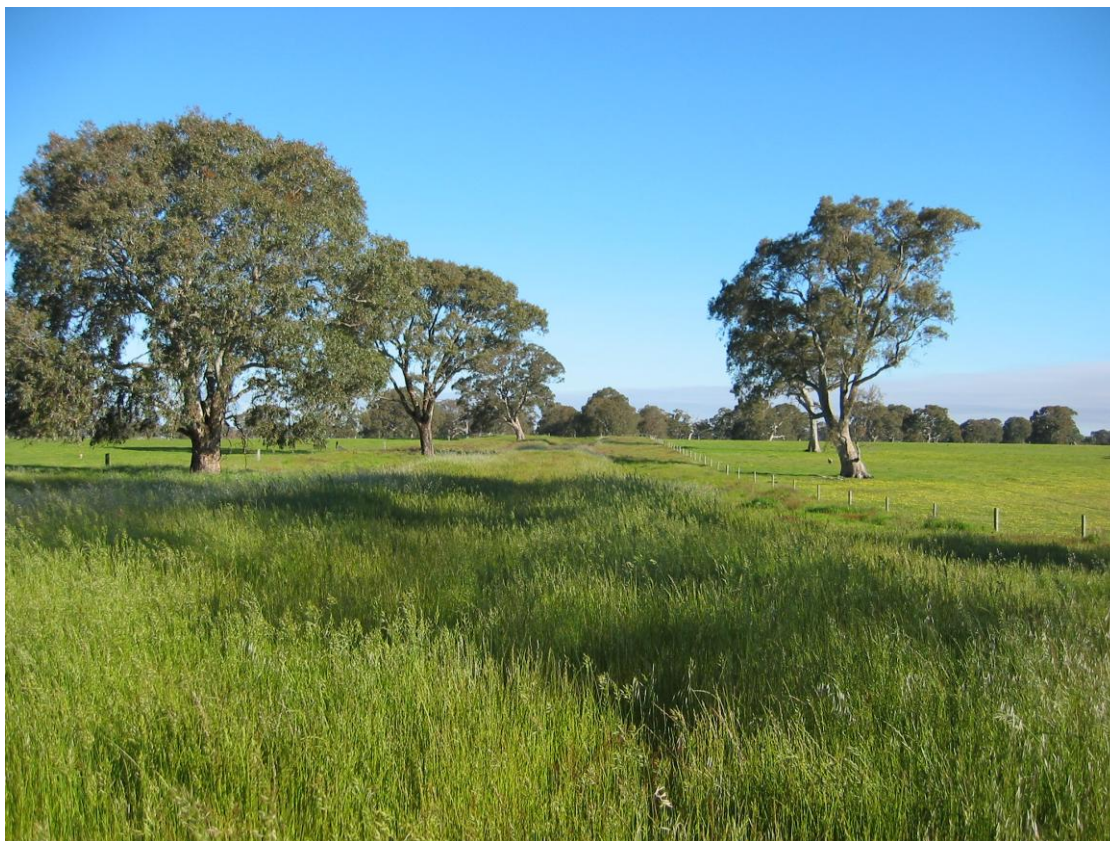
A comparatively treeless vista in the middle of Unit 8 (R) where there has been some intrusion of exotic species, whose presence could be reduced by burning. There is a good presence of native species, particularly sundews (*Drosera* spp.) and lilies (*Bulbine bulbosa*, *Arthropodium* spp. and *Caesia calliantha*), mixed with the pasture grasses. The central trail needs to be slashed to define the path.

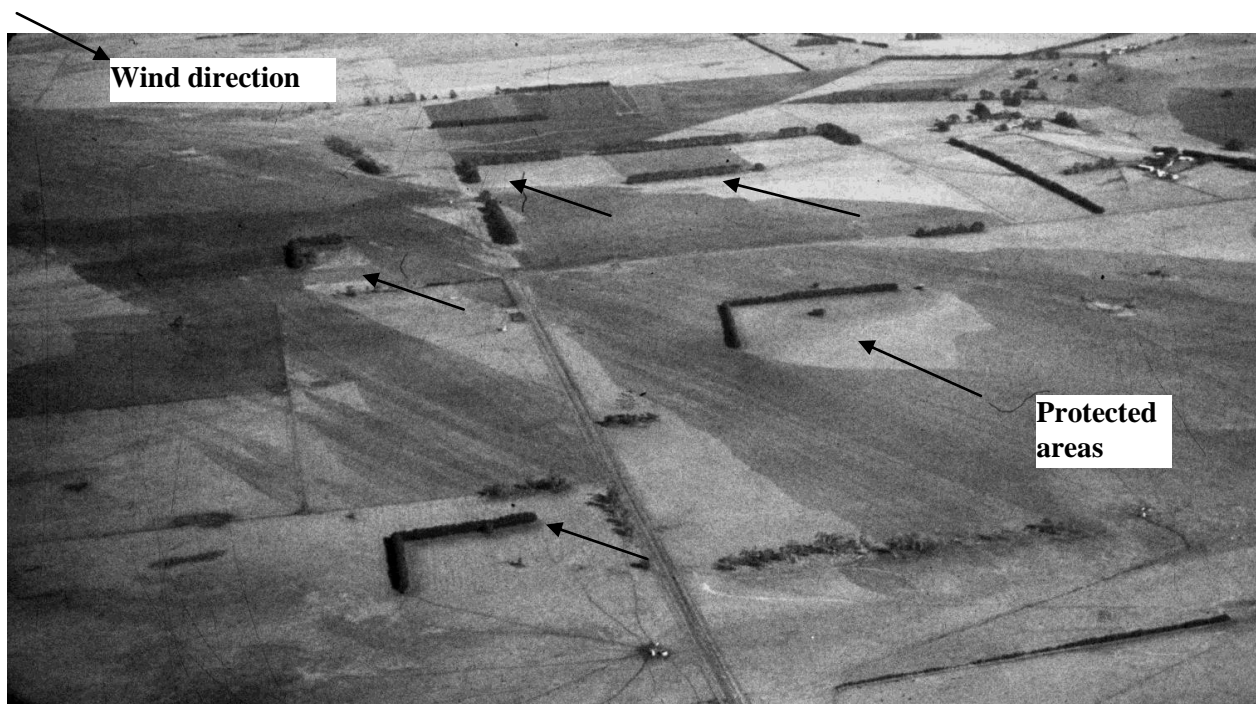
Far from being a hazard, trees can be of assistance in controlling a grassfire (fire speed is governed largely by windspeed and fuel load) and in protecting an area to the lee – see an example in the following photograph where areas behind windbreaks escaped the fire. From observations in other fires, the fire may creep in from the head and sides later but livestock sheltering in such areas walked out onto burned ground.

Grass fire in SW Victoria 16 Feb 1983 – effect of windbreaks in protecting paddocks from fire (arrows show areas protected from fire by windbreaks)
